HAUL TRUCK A-FRAME & PUMP MONITORING

CONTEXT

The customer had been concerned that some haul truck components, particularly the A-Frame bearing, were experiencing premature wear and failure from inadequate grease application. The fleet had experienced systemic A-frame failures resulting in expensive repairs and issues with asset availability.

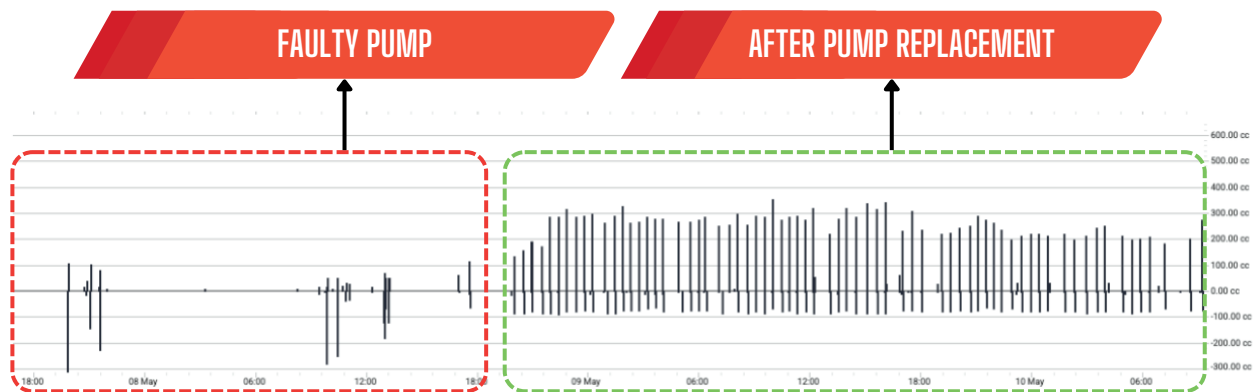
TRUCK 1 – ENDPOINT BF AT PUMP

GREASEBOSS DATA REVEALED FAULTY GREASE PUMP

Within hours of driving out of the workshop bay, the GreaseBoss data showed that the truck pump was erratic on timing and variable volumes. The A-frame bearing data aligned exactly with the pump data, indicating that this was a pump issue.

The maintenance team inspected and found the A-frame bearing dry and the failed grease pump. A new grease pump was installed.

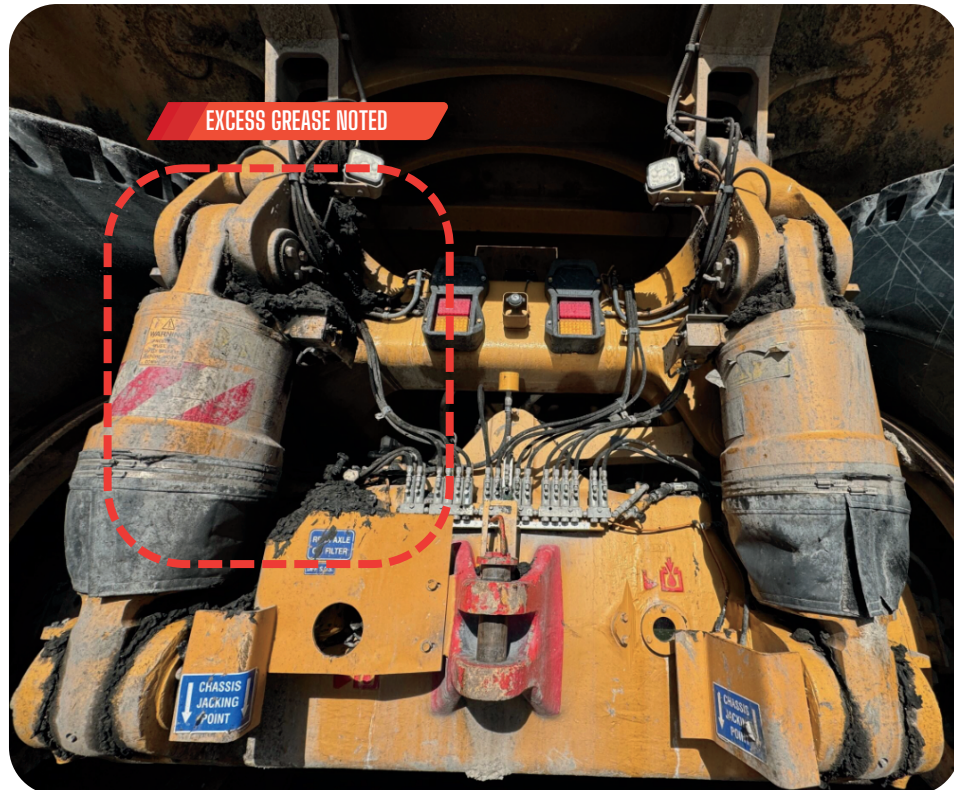
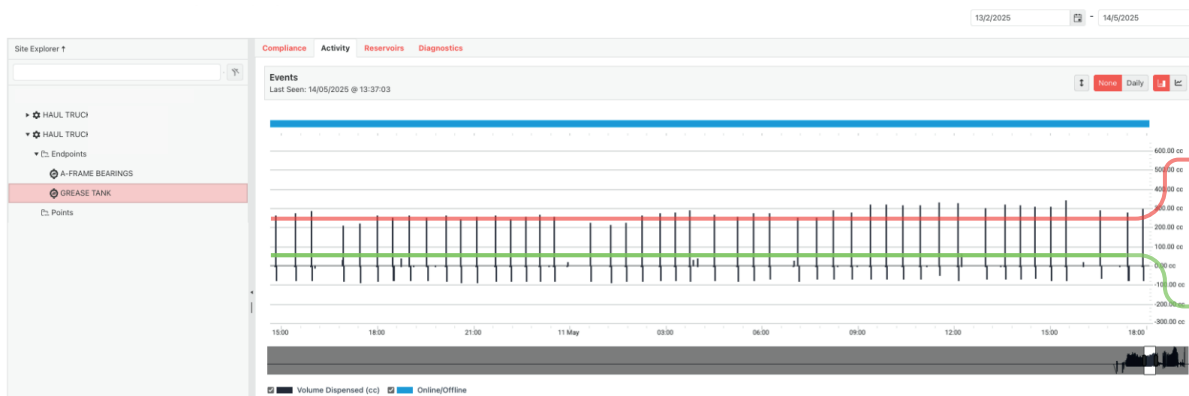
GREASEBOSS DATA REVEALED EXCESS GREASE BEING DISPENSED

After the pump was replaced, another issue became immediately apparent. The truck has 30 injectors set at 1.3cc and 1 x injector at 5cc for the A-Frame. The expected grease volume is approximately 50cc per cycle (refer below on #TR207 pump volumes).

GreaseBoss data showed 250+cc being dispensed each pump cycle - 5 times the expected amount.

GreaseBoss and the site maintenance team were able to use this data to determine that the truck had numerous bypassing injectors. This was confirmed by inspections showing excessive grease on some components. The truck was then scheduled for further maintenance to replace all faulty injectors.

ACTUAL GREASE DELIVERY =250cc

EXPECTED GREASE DELIVERY 50cc

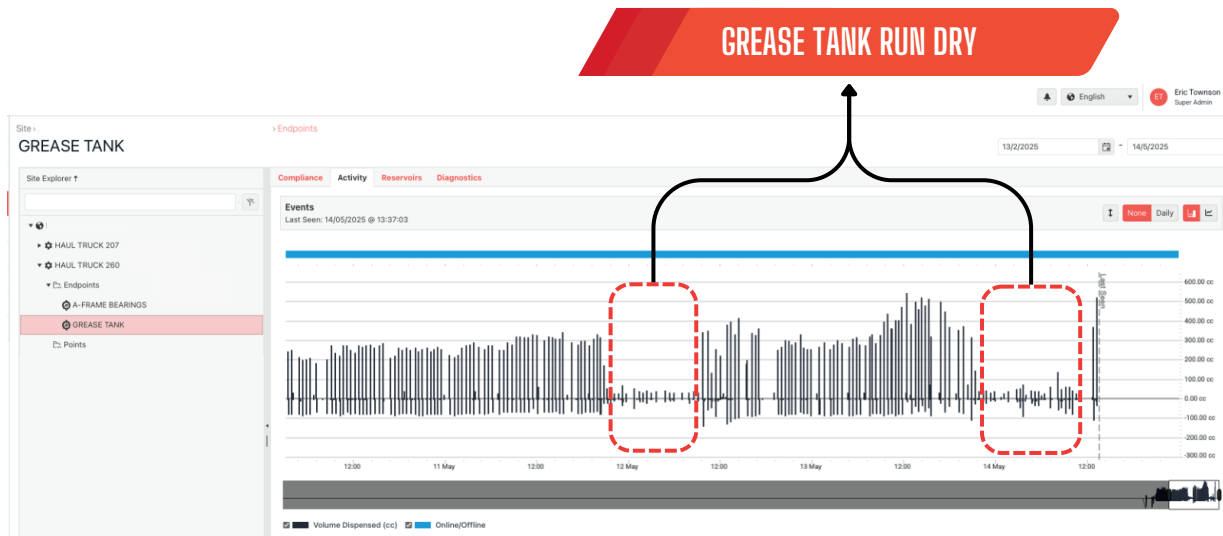
INDICATED EMPTY GREASE TANK

Due to the higher-than-expected grease volume being pumped into the truck's lube system, the grease tank ran dry twice, both times this was detected by the Endpoint BF data, allowing the team to schedule an ad-hoc grease tank refill, limiting the amount of time that the truck operated without grease to 12 hours each time. The standard grease tank filling regime was for fortnightly fills, so **without this visibility, this truck would have operated without grease for approximately 250 hours every fortnight (approx. 75% of the time).**

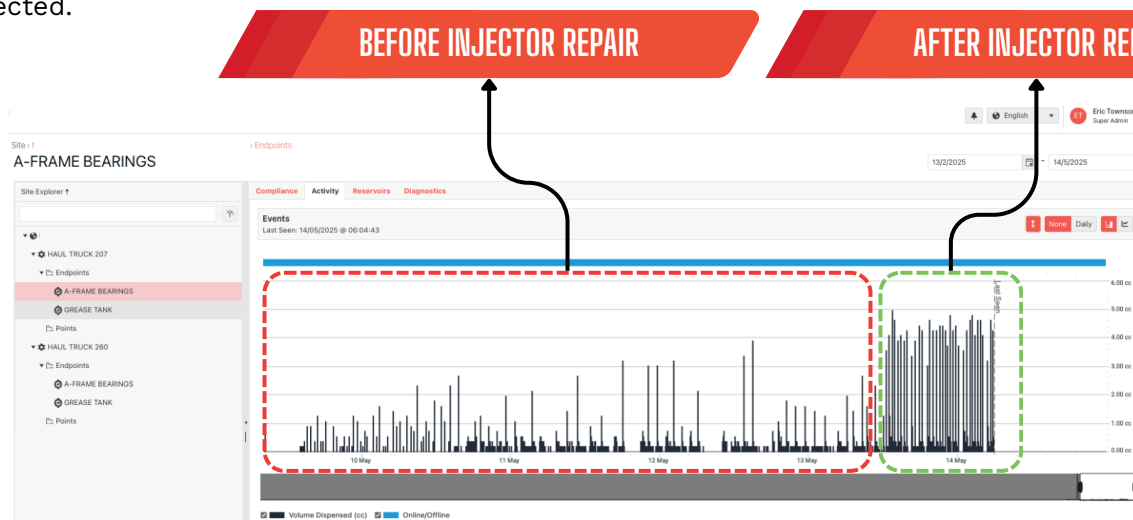
HIGHLIGHTED ERRATIC GREASE TO THE A-FRAME BEARING

Immediately after installation, the GreaseBoss data revealed that the A-Frame bearing was not receiving the expected 5cc per pump cycle. Data highlighted erratic grease to the A-Frame bearing rather than the expected, consistent injector volume. Site investigated and found the **injector had been incorrectly installed and tuned**. Once the injector was correctly installed and tuned, it behaved as expected.

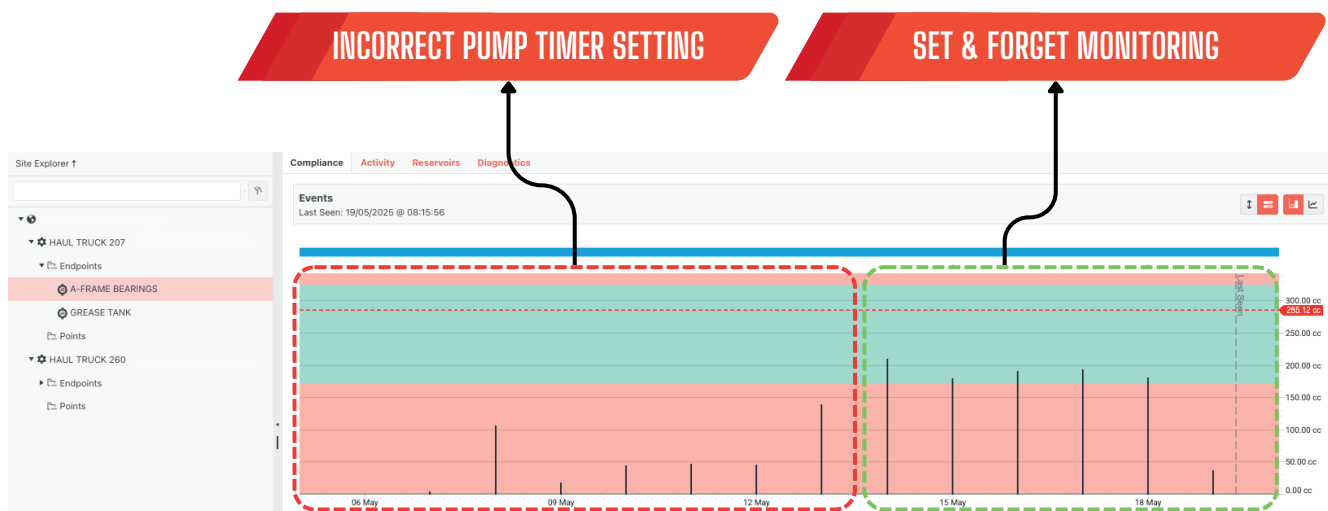
DETECTED INCORRECT PUMP TIMER SETTING

The GreaseBoss data indicated that the pump cycle time was running at over 60 minutes, instead of the desired 30 minute cycle. The maintenance team investigated and corrected the pump setting to 30 minute cycles.
