HAUL TRUCK A-FRAME & PUMP MONITORING

Site reliability engineers had been unable to determine the root cause of these failures and engaged GreaseBoss to run a pilot program to verify grease lubrication on two haul trucks a CAT 793 and CAT 789.

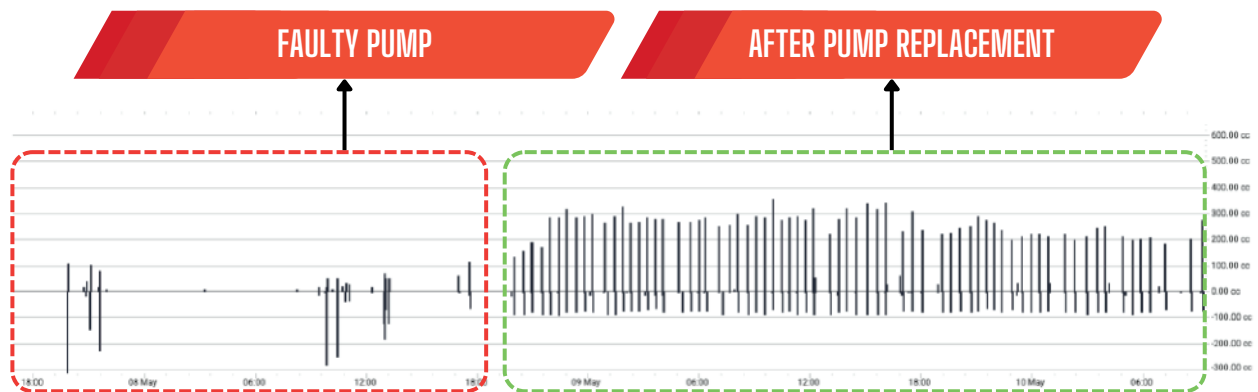
TRUCK 1 – ENDPOINT BF AT PUMP

Within hours of driving out of the workshop bay, the GreaseBoss data showed that the truck pump was erratic on timing and variable volumes. The A-frame bearing data aligned exactly with the pump data, indicating that this was a pump issue.

The maintenance team inspected and found the A-frame bearing dry and the failed grease pump. A new grease pump was installed.

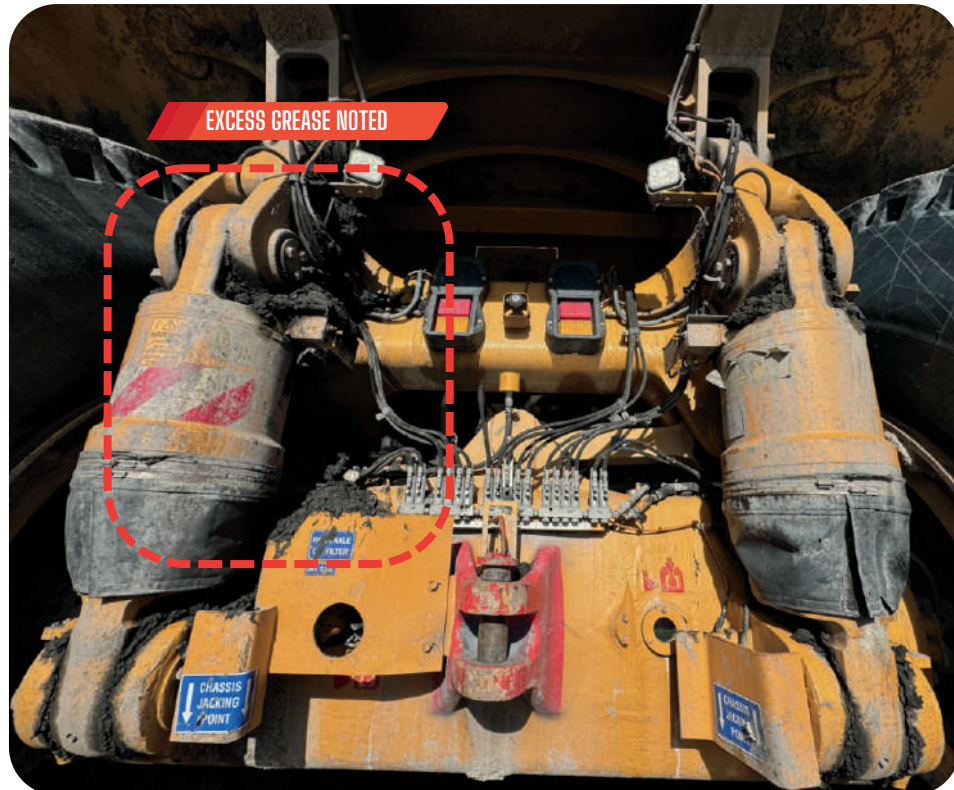
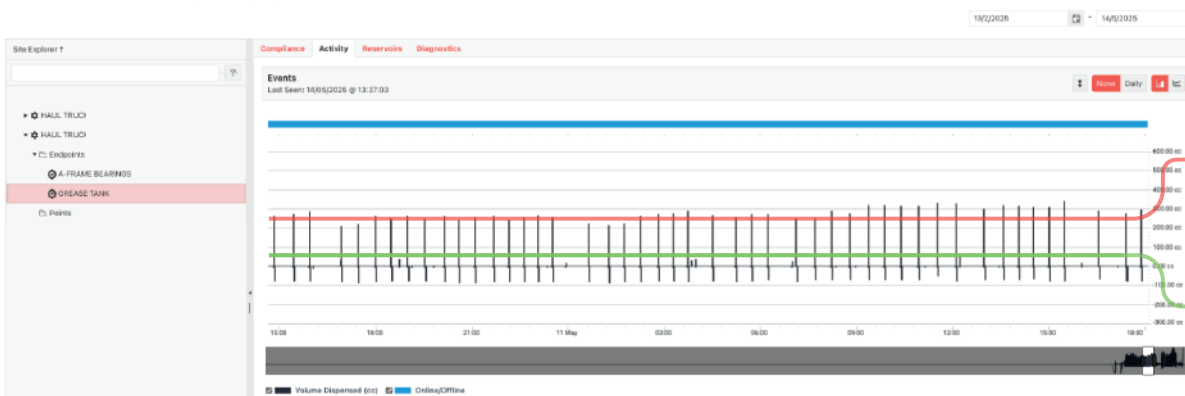
GREASEBOSS DATA REVEALED EXCESS GREASE BEING DISPENSED

After the pump was replaced, another issue became immediately apparent. The truck has 30 injectors set at 1.3cc and 1 x injector at 5cc for the A-Frame. The expected grease volume is approximately 50cc per cycle (refer below on #TR207 pump volumes).

GreaseBoss data showed 250+cc being dispensed each pump cycle - 5 times the expected amount.

GreaseBoss and the site maintenance team were able to use this data to determine that the truck had numerous bypassing injectors. This was confirmed by inspections showing excessive grease on some components. The truck was then scheduled for further maintenance to replace all faulty injectors.

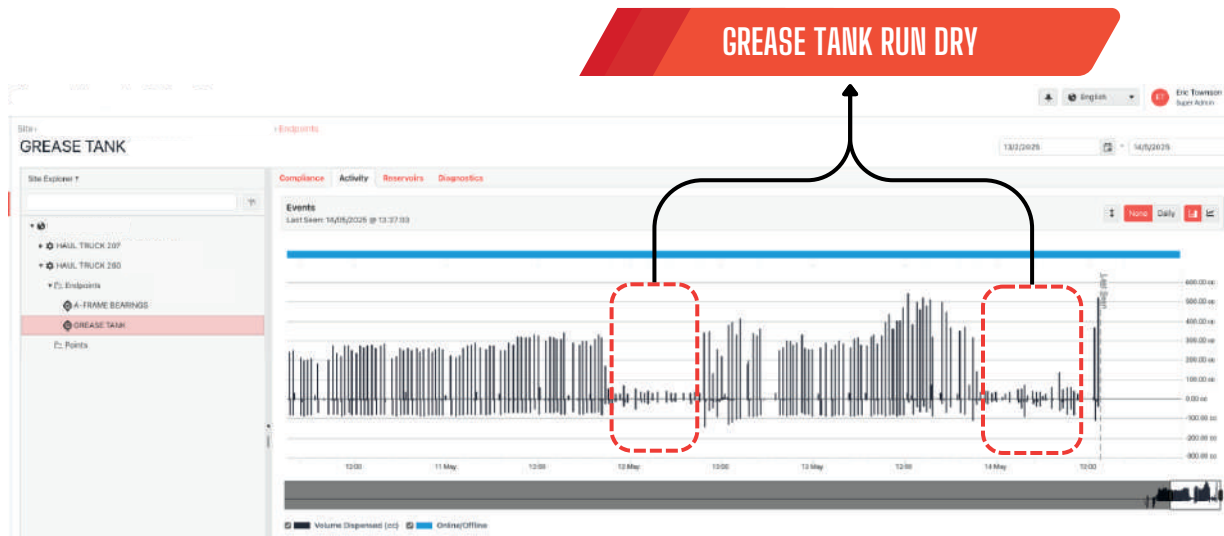
INDICATED EMPTY GREASE TANK

Due to the higher-than-expected grease volume being pumped into the truck's lube system, the grease tank ran dry twice, both times this was detected by the Endpoint BF data, allowing the team to schedule an ad-hoc grease tank refill, limiting the amount of time that the truck operated without grease to 12 hours each time. The standard grease tank filling regime was for fortnightly fills, so **without this visibility, this truck would have operated without grease for approximately 250 hours every fortnight (approx. 75% of the time).**

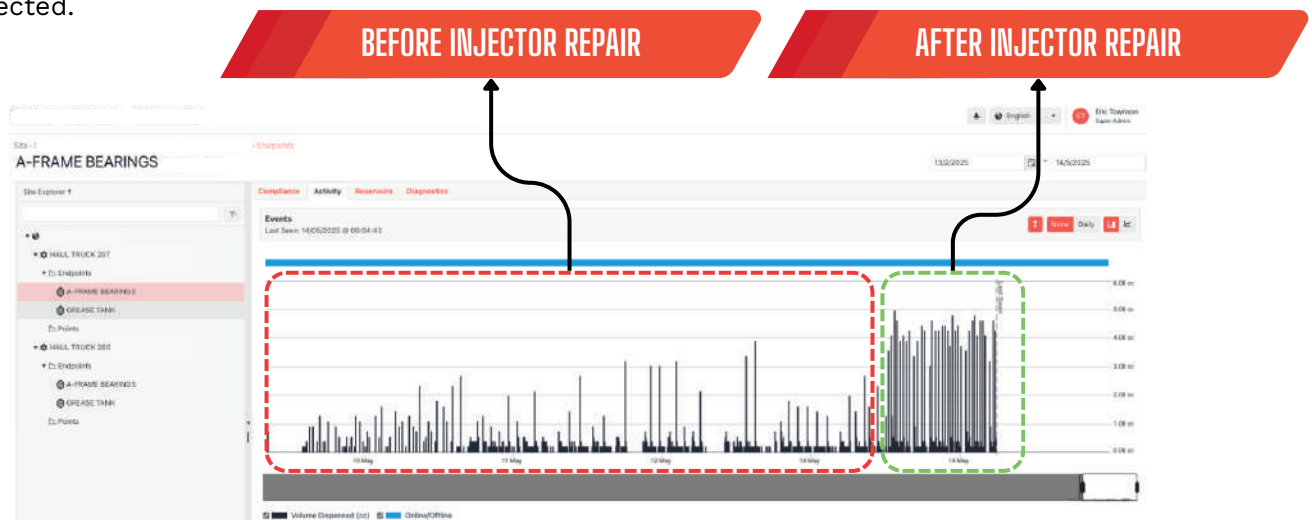
HIGHLIGHTED ERRATIC GREASE TO THE A-FRAME BEARING

Immediately after installation, the GreaseBoss data revealed that the A-Frame bearing was not receiving the expected 5cc per pump cycle. Data highlighted erratic grease to the A-Frame bearing rather than the expected, consistent injector volume. Site investigated and found the **injector had been incorrectly installed and tuned**. Once the injector was correctly installed and tuned, it behaved as expected.

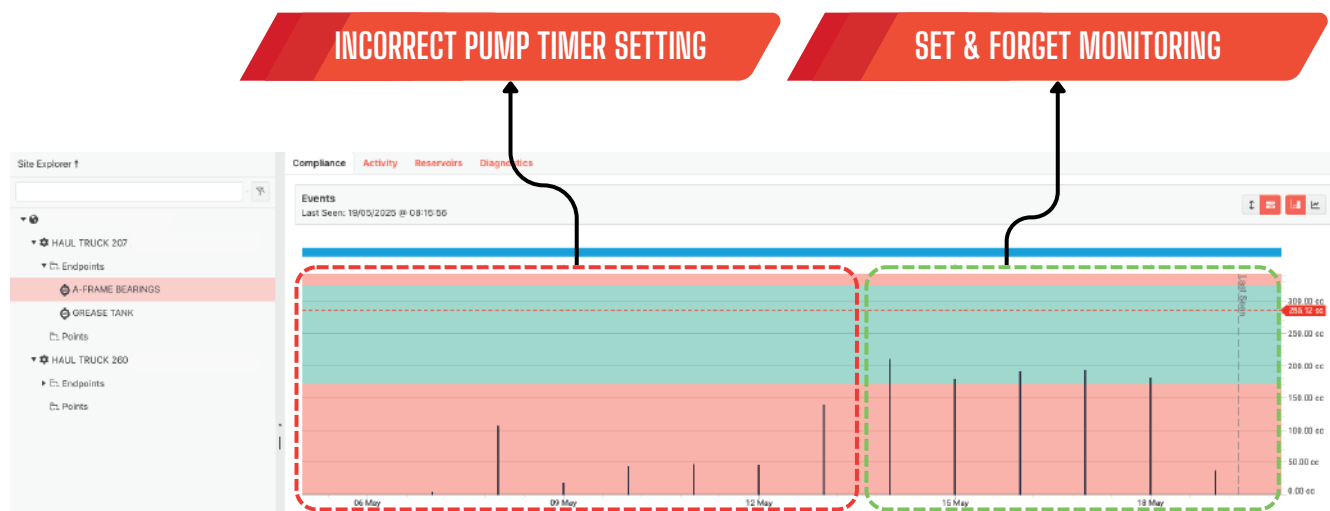
DETECTED INCORRECT PUMP TIMER SETTING

The GreaseBoss data indicated that the pump cycle time was running at over 60 minutes, instead of the desired 30 minute cycle. The maintenance team investigated and corrected the pump setting to 30 minute cycles.

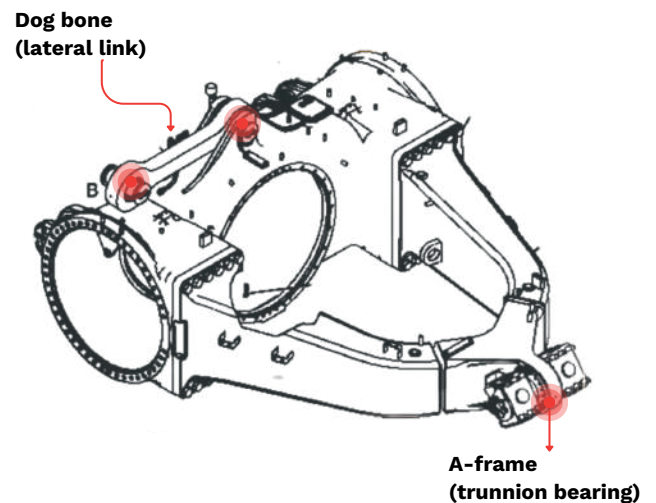
FAILED A-FRAME BEARING

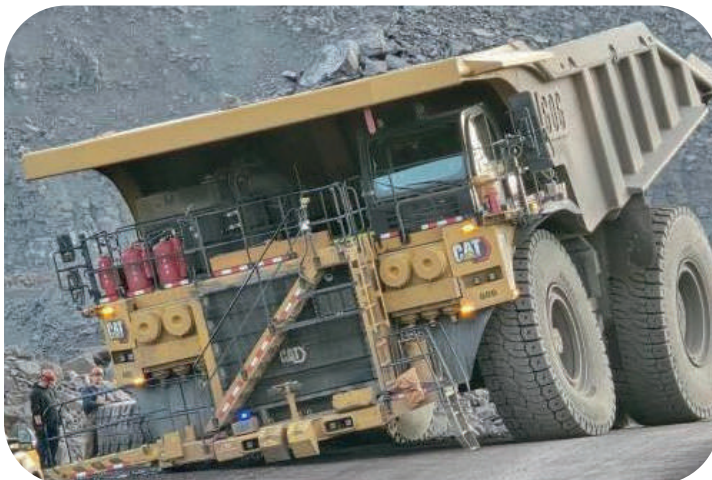
FAILED STEERING COMPONENTS
