# EXCAVATOR HOIST CYLINDER AND BUCKET PIN MONITORING- KOMATSU PC7000

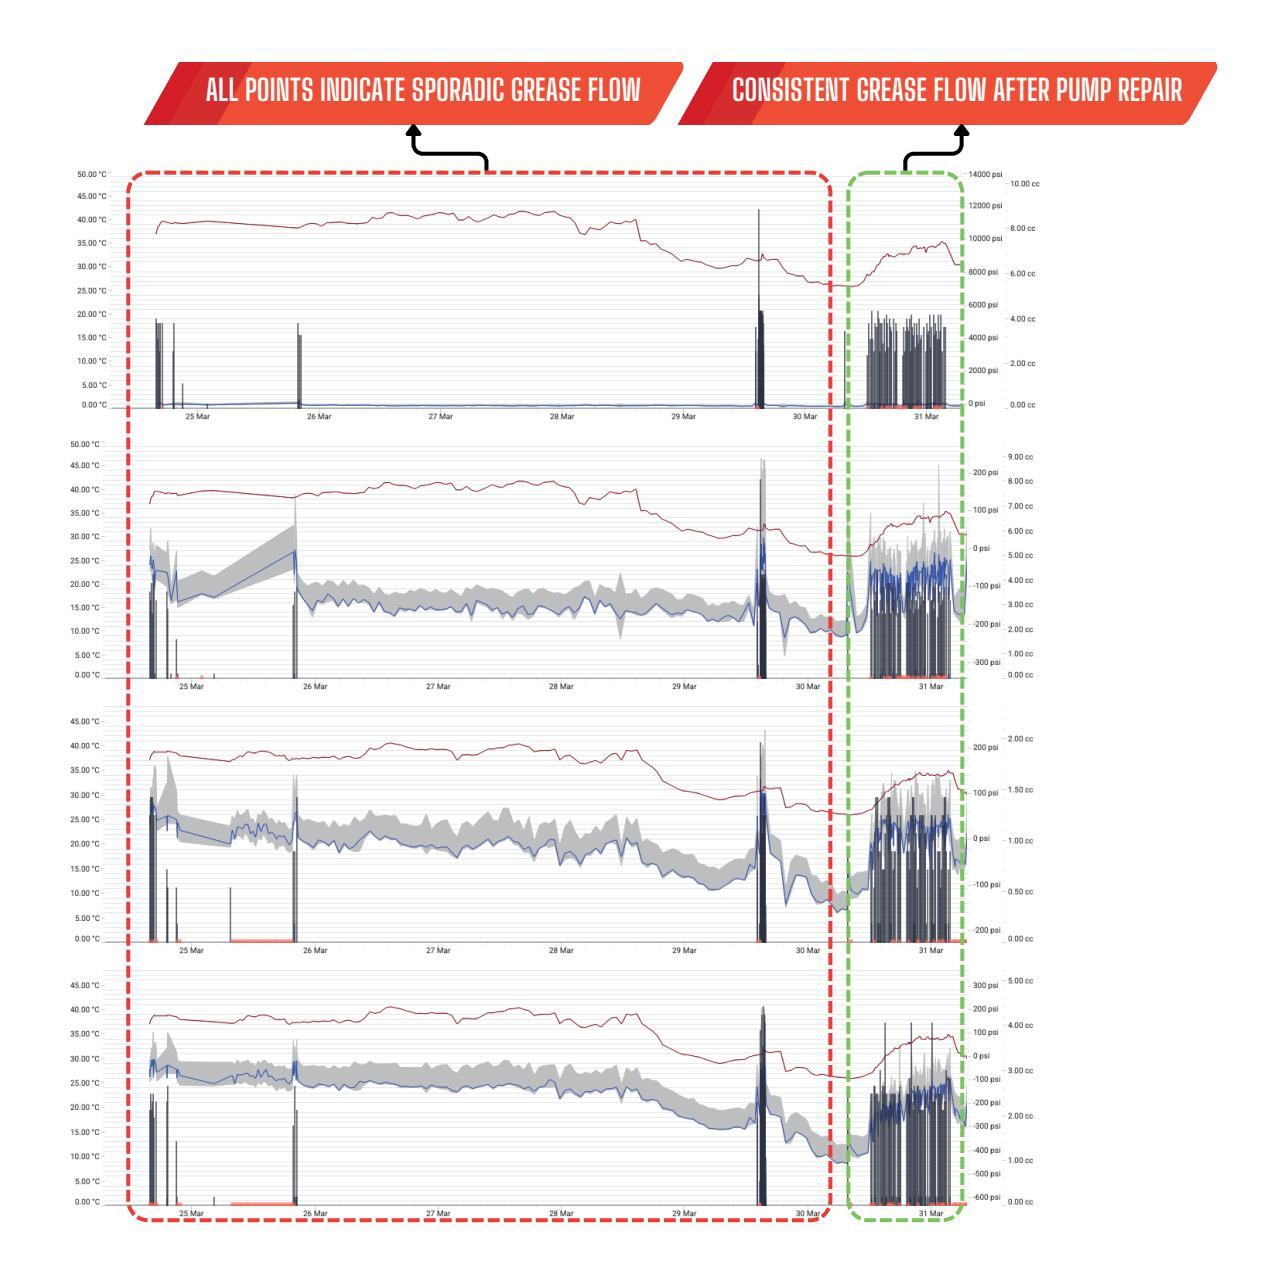
The two Endpoint MP2's monitoring the four hoist cylinder points revealed that **all four points exhibited the same pattern: intermittent pump activity followed by long periods with no grease flow.** This indicated a pump issue, which was confirmed when the customer discovered **a faulty cable harness providing electrical signals to the pump.**

ALL FOUR POINTS ON PUMP SYSTEM SHOWED IDENTICAL SPORADIC GREASE FLOW - INDICATING A PUMP FAILURE

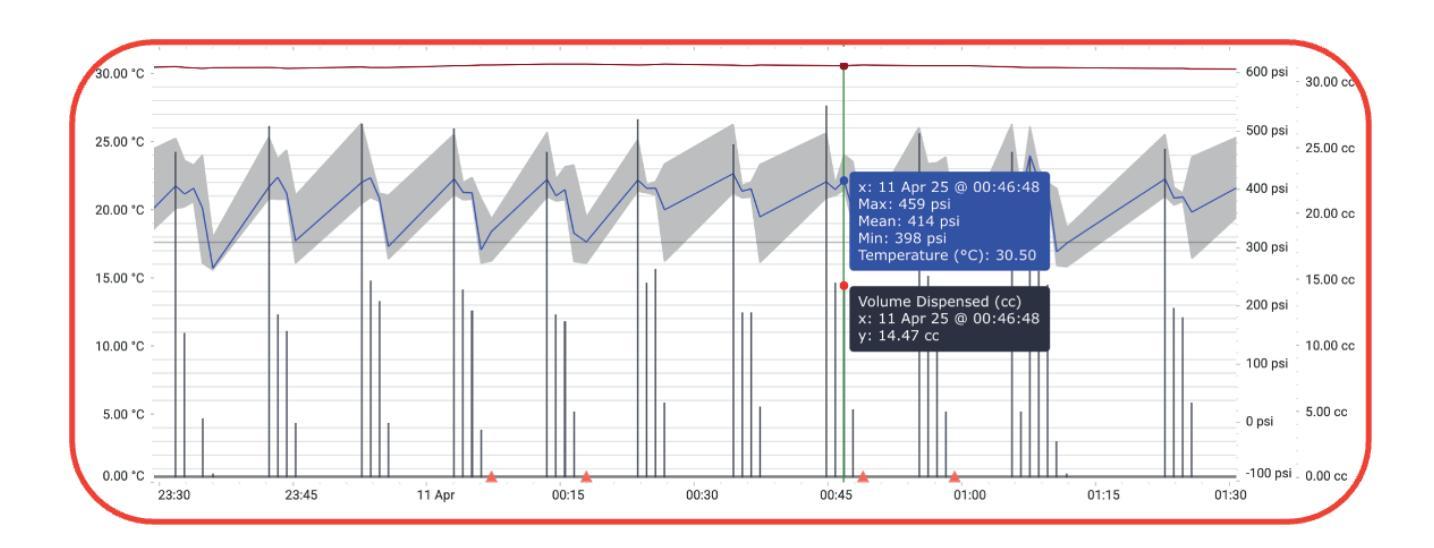
Raw data analysis enables full visibility. Every bar shows the volume of grease delivered over a 60 second period. The data shows that current injector setup delivers grease to pins over a 4 minute period at approximately 400 psi.
