ENDPOINT MP2 TEST PILOT SAVED => \$10 MILLION IN DOWNTIME

Over the past four months, GreaseBoss has piloted its Endpoint MP2 on mining excavators and ancillary equipment.

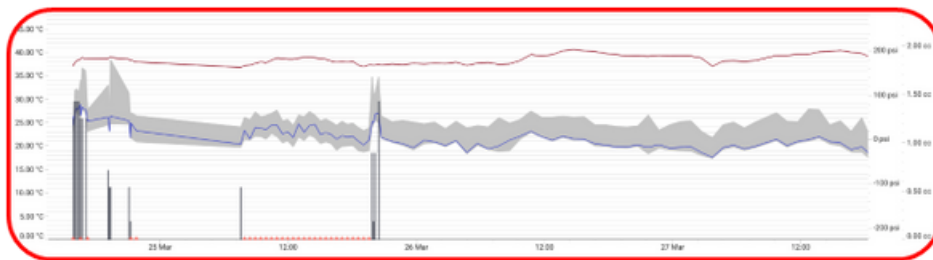
Of all four critical grease points monitored, **All of them showed the same trends of sporadic grease application** for short periods followed by no grease application for extended periods over the first three days of operation (see Figure 1 & 2).

Figure 2 - Boom foot LHS showing a lack of grease applied – the same trend across multiple points

Analysis of this data quickly identified the faulty wiring harness as the issue, ahead of the OEM monitoring system which failed to bring this issue to the attention of the maintenance team.

The data captured by the Endpoints also revealed a mistuned autolube system that caused the left hand side of the boom foot to receive less grease than the right hand side boom foot (refer to figures 1 & 2).

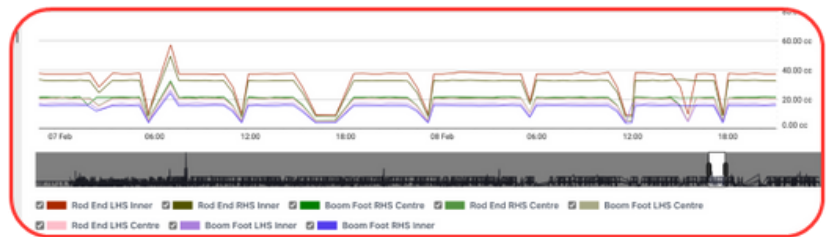
A “**healthy**” lube system will give a **consistent trend** in the injector volumes can be observed across a lube system, as shown in Figure 4.

Figure 4 - Healthy lube system - consistent trends across injectors.

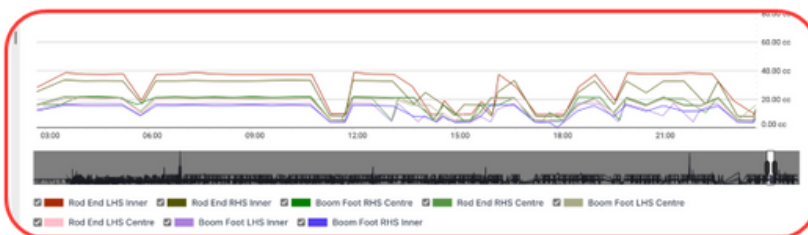
In one of the pilot assets, an injector on a swing box (not monitored directly by Endpoints) failed in bypass. The exact timing & impact that it had on the entire lubrication system is evident in Figure 5.

Figure 5 - Bypassing injector causing inconsistent trends across the system.

Analysing this data **prompted the maintenance team to investigate the lube system**, where the bypassing injector was then quickly found and rectified.
