# EXCAVATOR HOIST CYLINDER AND BUCKET PIN MONITORING- KOMATSU PC7000

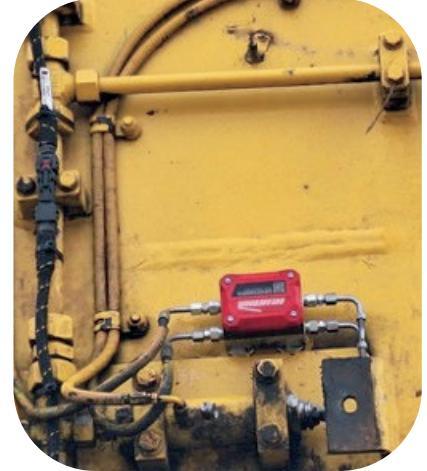
Endpoint MP2 monitoring bucket pins (LHS & RHS) – mounted on silicon magnets on the stick

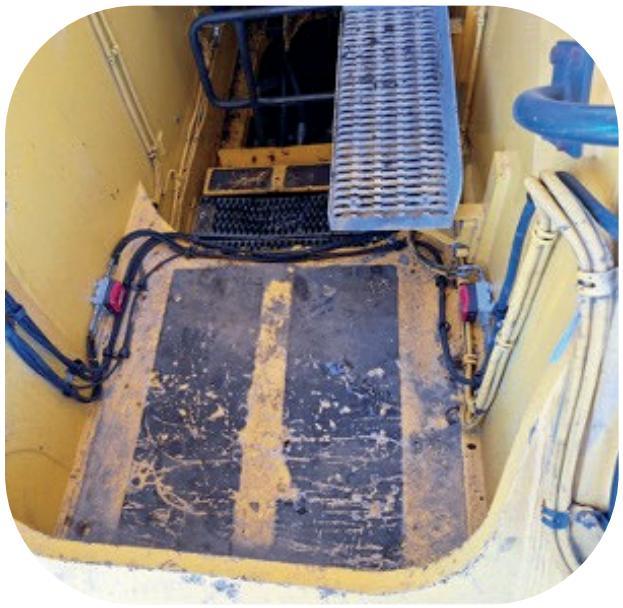
Endpoint MP2 monitoring hoist cylinders – mounted on silicon magnets in the "snake pit"

The two Endpoint MP2's monitoring the four hoist cylinder points revealed that **all four points exhibited the same pattern: intermittent pump activity followed by long periods with no grease flow.** This indicated a pump issue, which was confirmed when the customer discovered **a faulty cable harness providing electrical signals to the pump.**

ALL FOUR POINTS ON PUMP SYSTEM SHOWED IDENTICAL SPORADIC GREASE FLOW - INDICATING A PUMP FAILURE

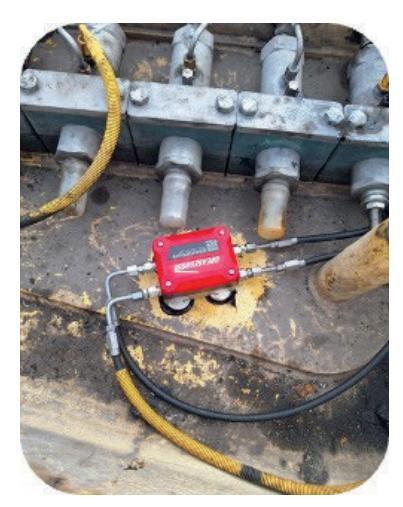
Raw data analysis enables full visibility. Every bar shows the volume of grease delivered over a 60 second period. The data shows that current injector setup delivers grease to pins over a 4 minute period at approximately 400 psi.

Endpoint MP2 monitoring H-link points – Mounted on silicon magnets in the H-link
